# Manhole Inspection Summary

Manhole # S07WW1014MH

Insp Date: **9/26/06 3:22 PM**

**Location** Address: **2803 woodcrest**

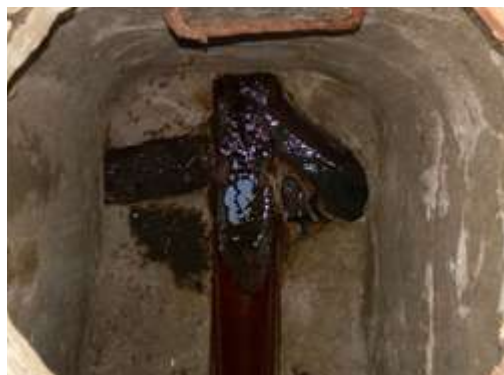
Top View

Corbel and Barrel infiltration. Corroded steps. Channel debris.

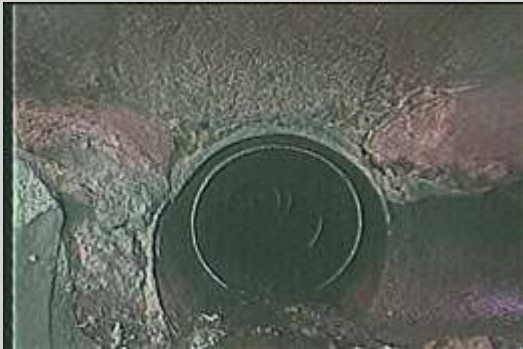
### 8 in. Circular Gravity Sewer Pipe Out @ 12 O'Clock

Deposits: ☐ None ☐ Mud ☒ Sludge ☒ Debris ☐ Grease

Silt Depth: **1** (in.) Deposits Extent: **Light**

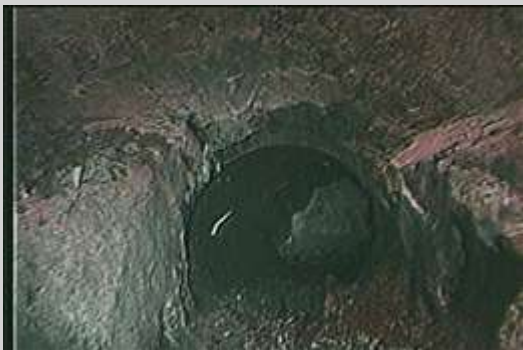
Pipe In @ 9 O'Clock

Deposits: ☐ None ☒ Mud ☒ Sludge ☐ Debris ☐ Grease

Silt Depth: **3** (in.) Deposits Extent: **Medium**

Connects To: **Stub connection / abandoned**
